# Environmental Monitoring

- Lillgrund Offshore Wind Farm

Lillgrund Pilot Project

February 2009

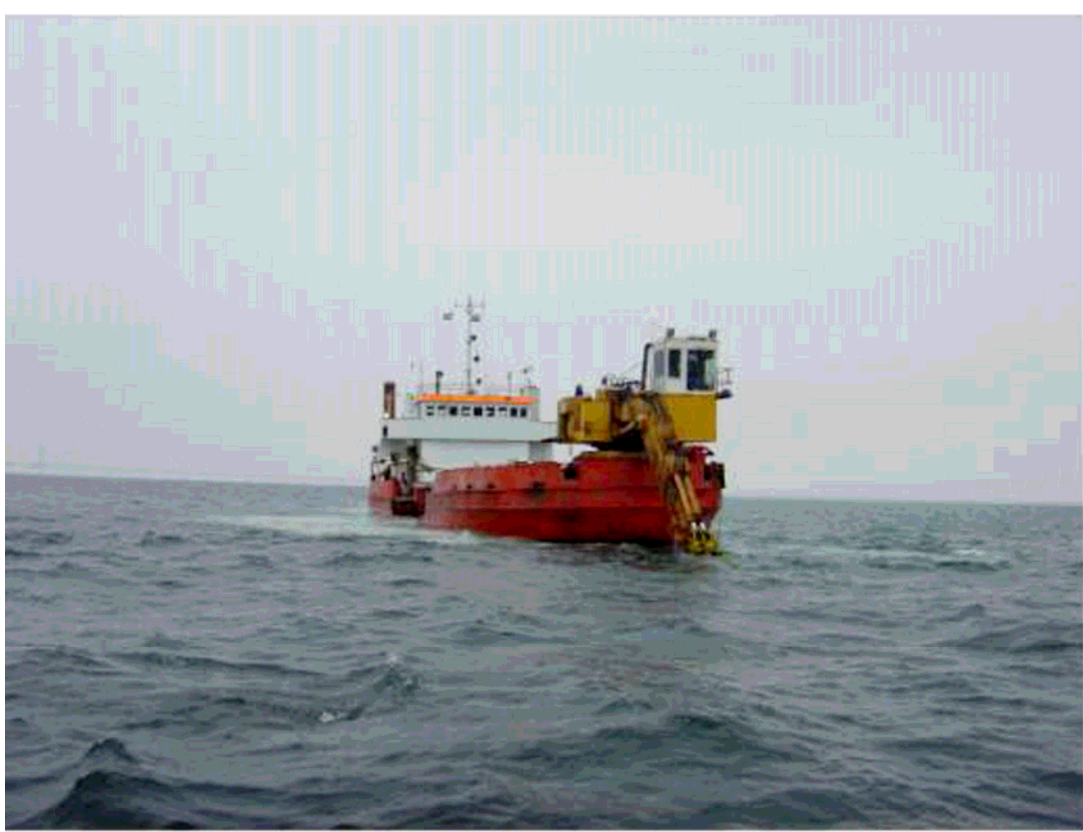
Figure 8-1 Dredger in operation at Lillgrund

Figure 8-1 shows dredging works performed at Lillgrund by the dredger Grete Fighter.

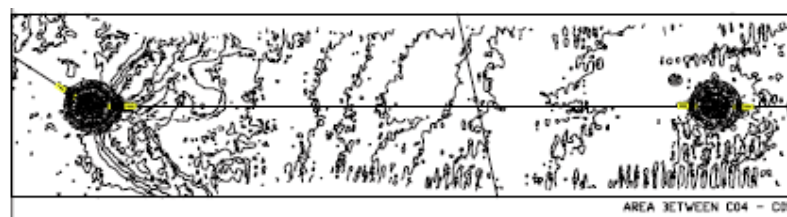
**Figure 8-2 Results from in-survey between foundation C04 and C05.**

The marine survey vessel M/V SOUND SEEKER, equipped with Multibeam echo sounding equipment, performed the survey. The vessel is positioned by the use of DGPS working in RTK mode. The area covered by the survey was approximately 30 meters. A typical result from the in-survey is shown in Figure 8-2.

Before the trenching work started, an in-survey of the cable routes between the wind turbines and the transformer platform, as well as the export cable-landing location was carried out. The purpose of the survey was to document any excessive amounts of boulders or other obstacles e.g. wrecks, cables, pipes etc. existing along the seabed of the cable route which might interfere with the trenching or the cable laying. The survey also constitutes a reference for the backfill work.

The results from the comparison between the in- and out-surveys were presented by the contractor in the form of diagrams showing the differences by curves and by colours. Figure 8-3 shows the differences between the in- and out-survey performed between foundations C04 and C05 in the colour version. The green fields indicate a seabed surface that has been refilled within the stipulated tolerance of  $\pm 0,3$  meters. Grey fields indicate that the seabed surface is within a tolerance of  $-0,6$  meters and yellow fields within a tolerance of  $+0,6$  meters.

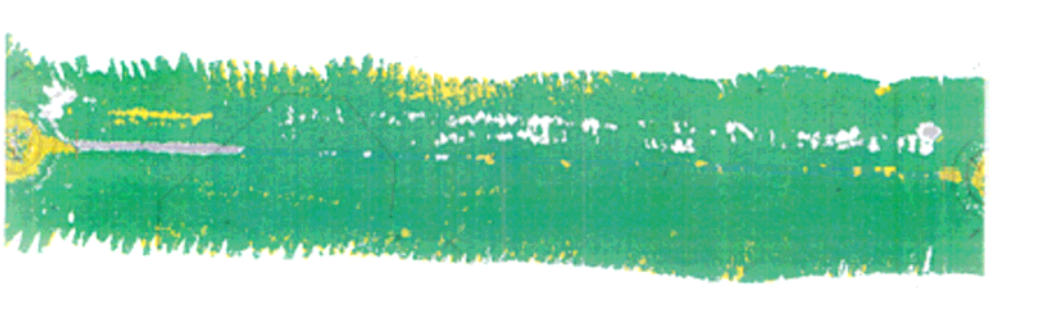
**Figure 8-3 Results from comparison of out-survey with in-survey between foundations C04 and C05.**

On the left hand side of the figure (close to the foundation) it can be seen that the backfilling level is not sufficient.

The results showed that 94% of the area within the wind farm and 87% of the area along the export cable was refilled within the stated tolerances. Based on the results, some additional backfilling with existing material was done close to the foundations. The deviations between in- and out-survey was mainly dependent on the time between the measurements. During that lapsed time, some heavy storms and/or the heavy currents at Lillgrund could have caused the movement of material on sea bottom.
